DEPARTMENT OF TRANSPORTATION**DIVISION OF ENGINEERING SERVICES**

Contract #: 04-0120F4Cty: SF/ALA Rte: 80 PM: 13.2/13.9File #: 70.28**WELDING INSPECTION REPORT****Resident Engineer:**Pursell, Gary**Address:** 333 Burma Road**City:** Oakland, CA 94607**Report No:** WIR-004737**Date Inspected:** 21-Nov-2008**Project Name:** SAS Superstructure**OSM Arrival Time:** 830**Prime Contractor:** American Bridge/Fluor Enterprises, a JV**OSM Departure Time:** 1700**Contractor:** Japan Steel Works**Location:** Muroran, Japan**CWI Name:** Chung-Fu Kuan**CWI Present:** Yes No**Inspected CWI report:** Yes No N/A**Rod Oven in Use:** Yes No N/A**Electrode to specification:** Yes No N/A**Weld Procedures Followed:** Yes No N/A**Qualified Welders:** Yes No N/A**Verified Joint Fit-up:** Yes No N/A**Approved Drawings:** Yes No N/A**Approved WPS:** Yes No N/A**Delayed / Cancelled:** Yes No N/A**Bridge No:** 34-0006**Component:** Tower, Jacking and Deviation Saddles**Summary of Items Observed:**

The following report is based on METS observations at Japan Steel Works (JSW) in Muroran Japan. Current work: Casting, machining and nondestructive testing of Saddles.

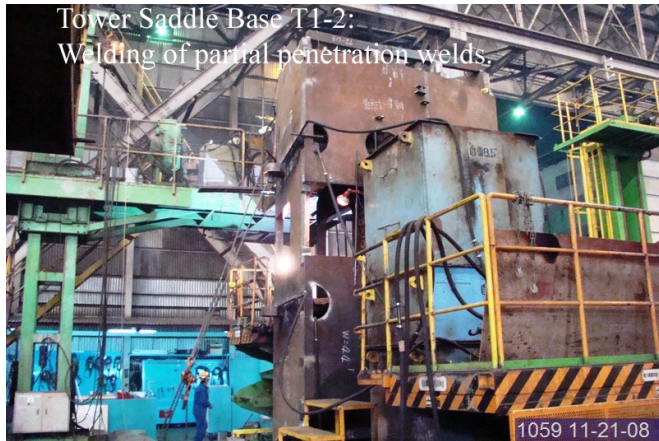
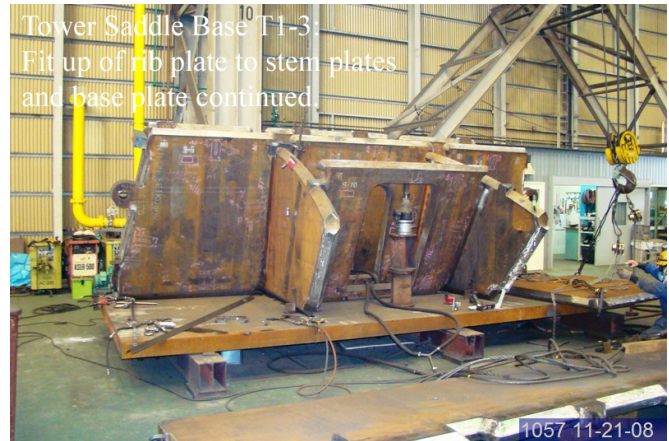
The QA inspector observed the in process welding of the structural steel plates for the Tower Saddle Base T1-2. The JSW welding personnel Satoru Watanabe, ID 08-5159 continued the fill welding of joint 8Y-5V (2-3) in the flat position. Takatoshi Inoue, ID 08-5163 continued the fill welding of joint 8Y-12V (2-2) in the flat position. The welding was performed utilizing the gas shielded flux cored arc welding process per the welding procedure specification (WPS) SJ-3012-3. Intertek Testing Services Quality Control (QC) inspector Mr. Chung-Fu Kuan monitored the welding parameters and heat control at periodic intervals. The minimum preheat temperature of 110°Celsius and maximum interpass temperature of 260° Celsius were verified to meet the WPS requirements by Mr. Kuan and the QA inspector utilizing Tempilstik temperature indicators. This data was entered into the QC inspector's daily log, identifying the location on a weld map. The work was not completed on this date and

The QA inspector observed the in process assembly layout and fit-up operation of the structural steel plates for the Tower Saddle Base T1-3. The center rib plates were aligned on the base plate and to the stem plate. The JSW fitter personnel Kiyotaka Koanagi performed the layout in accordance with approved drawings. The JSW welding personnel Yoshihiro Ohta, ID 08-2017 performed the in process tack welding of joint 9Y-6V (3-2) in the vertical position. The welding was performed utilizing the Shielded Metal Arc Welding (SMAW) process per the welding procedure specification (WPS) SJ-3012-2. The welding parameters and heat control were monitored by Intertek Testing Services Quality Control (QC) inspector Mr. Chung-Fu Kuan at periodic intervals. The minimum preheat temperature of 110°Celsius was verified to meet the WPS requirements by Mr. Kuan and the QA inspector utilizing Tempilstik temperature indicators. This data was entered into the QC inspector's daily log, identifying the location on a weld map. The work was not completed on this date and appears to meet the minimum requirements of the welding procedure specification and contract documents.

Two JSW employees were observed grinding areas where excess material has been removed from the exterior surface of the casting W2-W3. The grinding was performed to smooth the surface of the casting where the Air-Carbon Arc method was utilized. Work was not completed on this date and appears to meet the minimum requirements of the contract documents.

Two JSW employees were observed removing excess riser material from the exterior surface of the casting T1-3. The material was removed utilizing the Air-Carbon Arc method. Work was not completed on this date and appears to meet the minimum requirements of the contract documents.

The following digital photographs illustrate observations of the activities being performed.
